Manhole Inspection Summary

Manhole # S25M__027MH

Insp Date: **3/3/08 10:02 AM**

Location Address: **S.CAREY ST.**

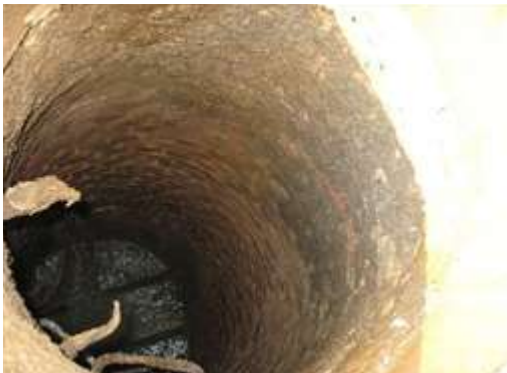
Misc 5

MUD FROM CHIMNEY TO CORBEL
INDICATING INFILTRTION

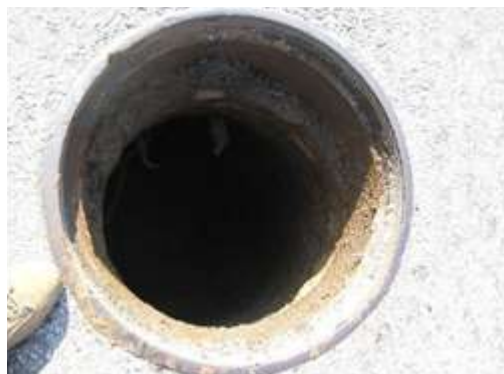
Defect 5

Offset: **2** (in.)

FRAME OFFSET

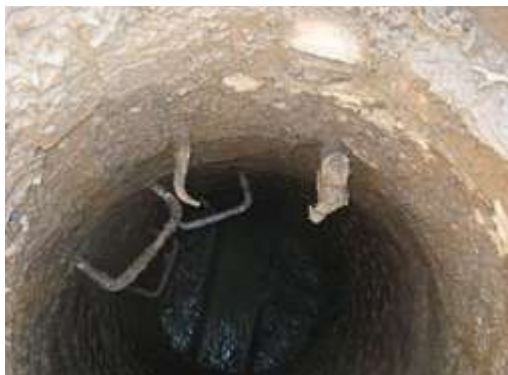
Defect 3

Count: **7** Missing: **1** ☒ Corroded

steps missing/corroded

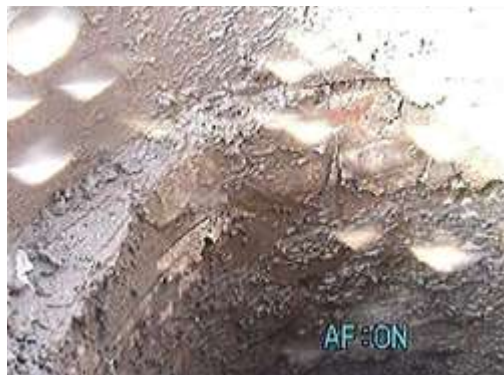
Defect 2

Infiltration: ☐ None ☐ Joint ☒ Cracks ☒ Mortar ☐ Roots ☒ Wall

EVIDENCE OF INFILTRATION MUD DEPOSITS ON CHIMNEY AT CRACKS, MORTAR, & WALL

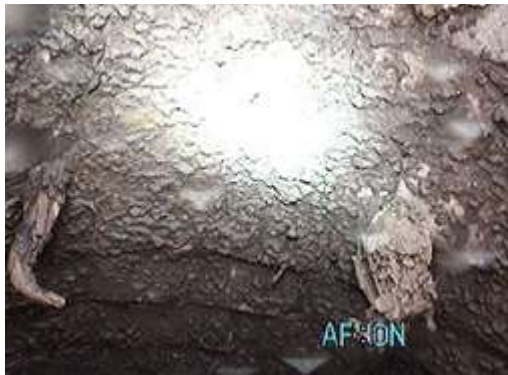
Defect 1

Infiltration: ☐ None ☐ Joint ☐ Cracks ☐ Mortar ☐ Roots ☒ Wall

signs of infiltration at corbel wall

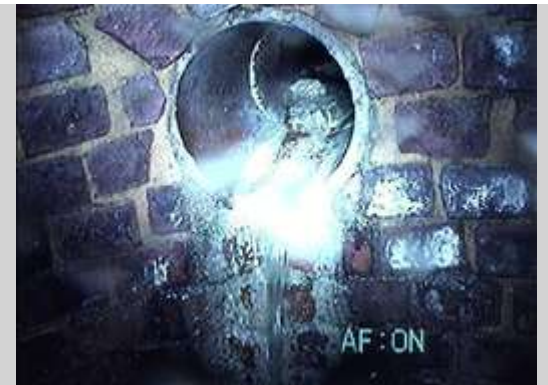
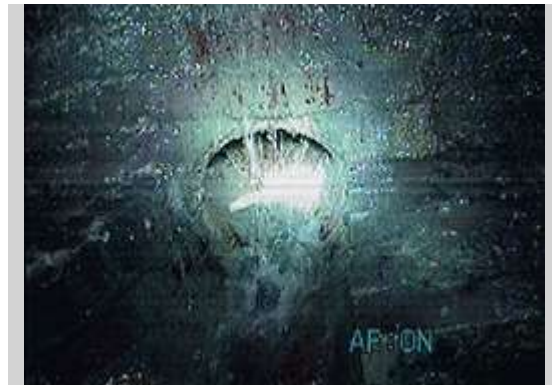
3 O'Clock Inflow

Pipe Height: **7.2** (in.) Rod and Bar (Angled)
Pipe Material: **Clay** ☐ Pipe Lined
Invert Depth: **13.70** (ft.) Flow Characteristics: **Fast**
Deposits: ☐ None ☐ Mud ☐ Sludge ☒ **Debris** ☐ Grease
Silt Depth: **2** (in.) Deposits Extent: **Light**
Infiltration: **None** Pipe Seal Cond: **Sound**

Drop: **Inside** Rod and Bar
Angled: **Yes** Reading: **13.50** (ft.)
Inv Depth: **14.50** (ft.)
Drop Condition: **Open**
